# **Debris/Ice/TPS Assessment and Integrated Photographic Analysis of Shuttle Mission STS-84**

**DEBRIS/ICE/TPS ASSESSMENT  
AND  
INTEGRATED PHOTOGRAPHIC ANALYSIS  
OF  
SHUTTLE MISSION STS-84**

**15 May 1997**

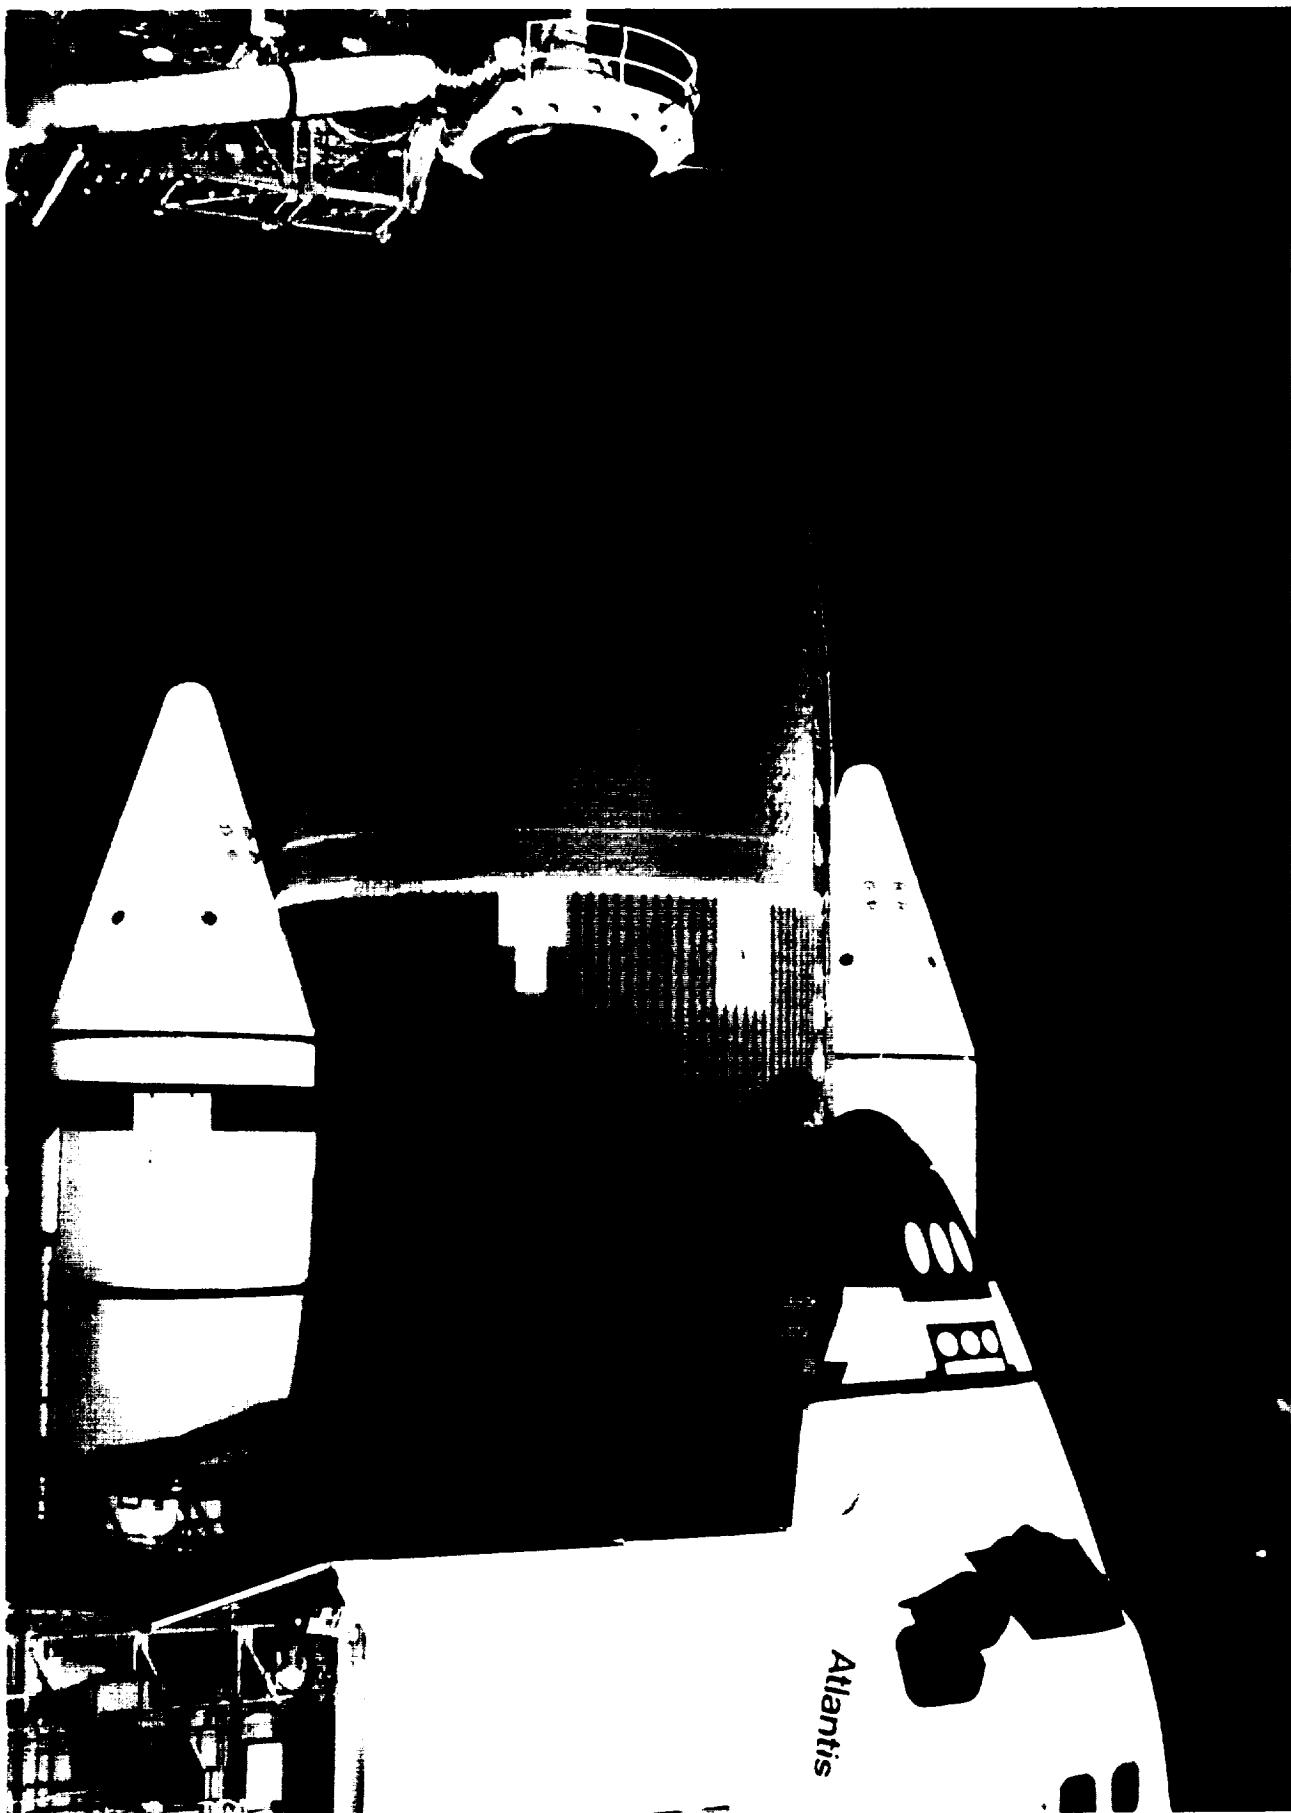
**Photo 3: LO2 Tank and Intertank After Cryoload**

The Final Inspection Team observed light condensate, but no ice or frost accumulations, on the LO2 tank. TPS surface temperatures averaged 62 degrees F.

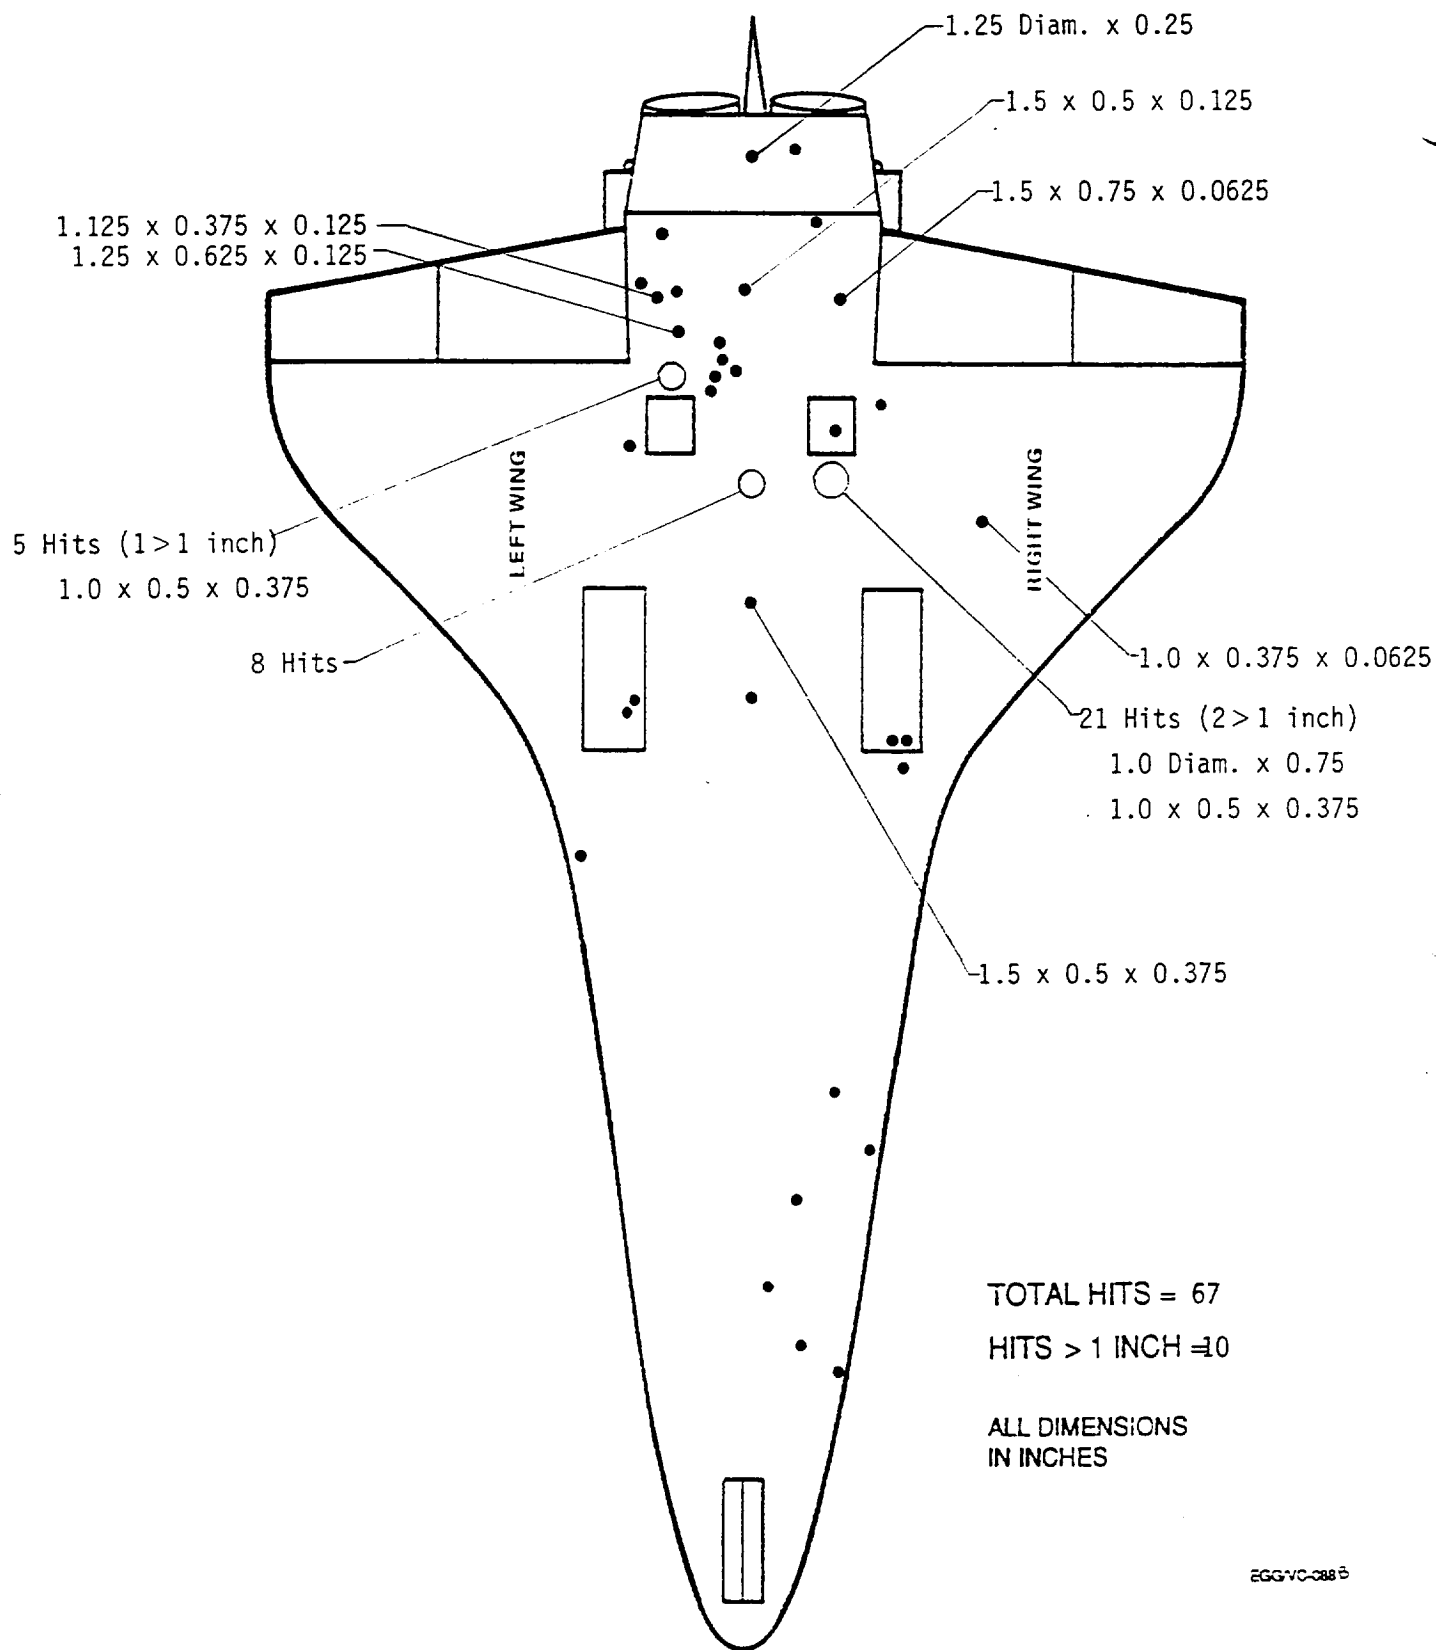
**Figure 1: Orbiter Lower Surface Debris Damage Map**

The Orbiter lower surface sustained a total of 67 hits, of which 10 had a major dimension of 1-inch or larger. The largest lower surface tile damage site was located on the Orbiter centerline between the two MLG doors. The site measured 1.5-inches long by 0.5-inch wide by 0.375-inch maximum depth.

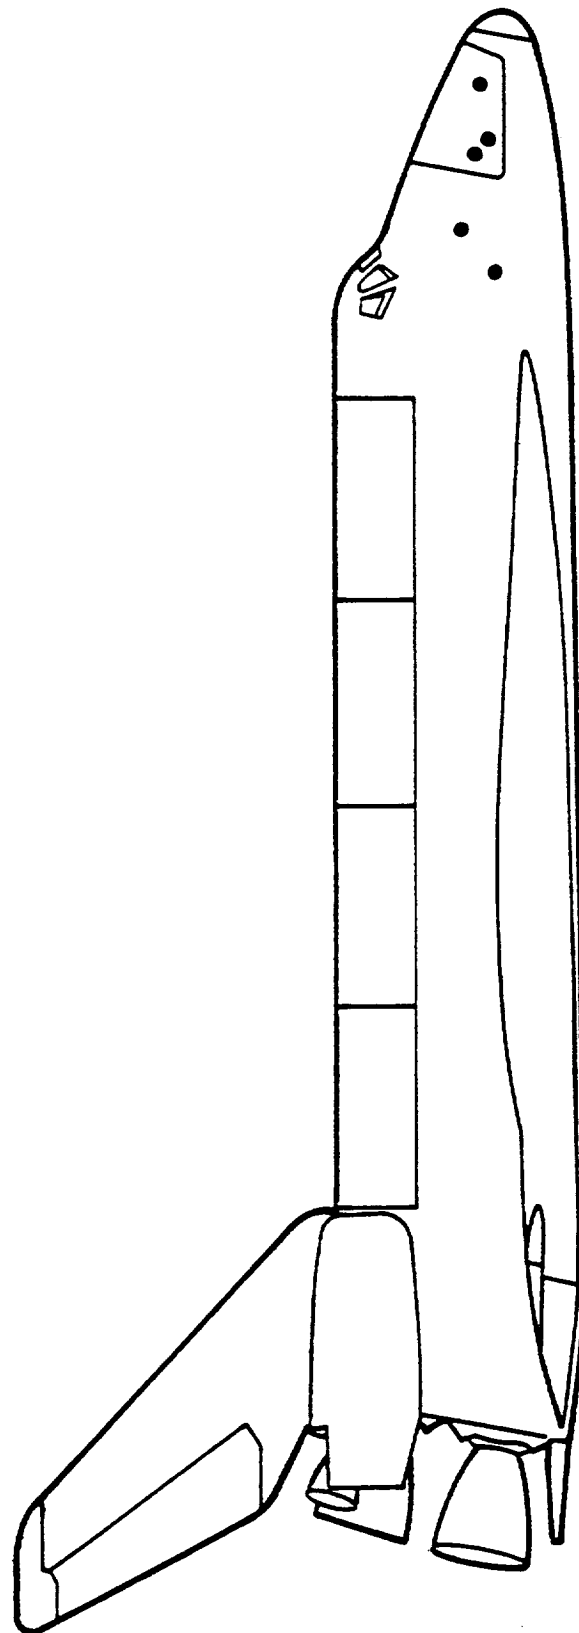
**Figure 3: Orbiter Right Side Debris Damage Map**

TOTAL HITS = 5  
HITS > 1 INCH = 0

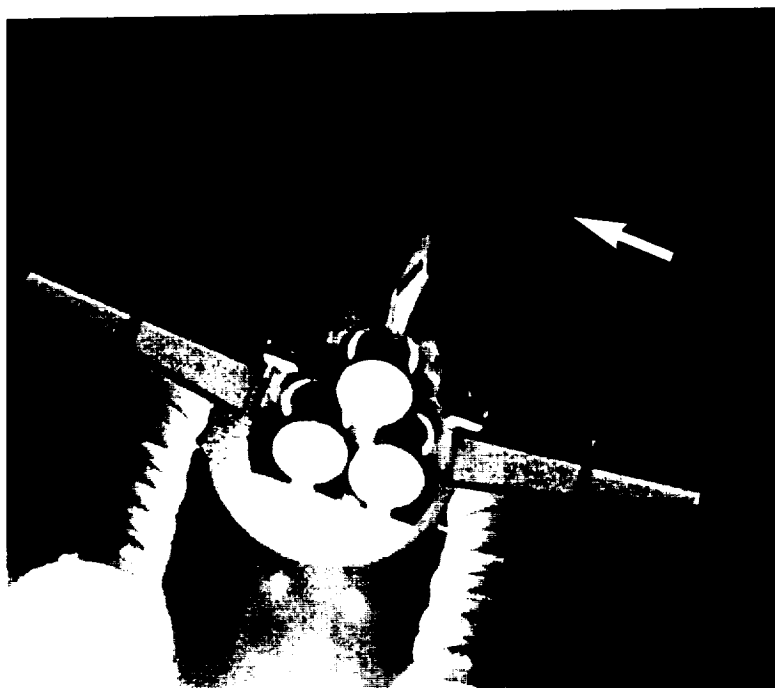
Figure 2.2 (A) RCS Paper Passing over Right Wing

A single piece of debris, probably RCS paper, was seen falling along the right side of the Orbiter fuselage and over the right wing after the roll maneuver at 08:08:02.6 UTC (Camera E52).

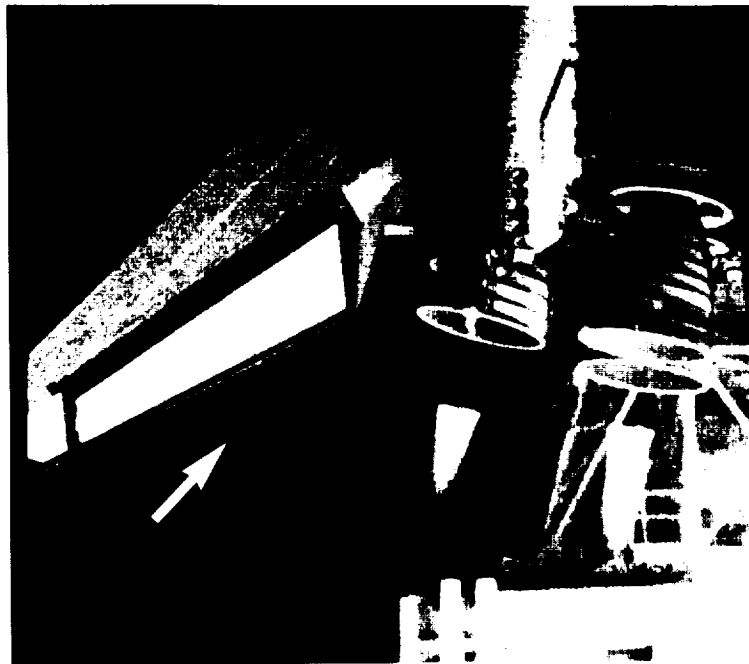
Figure 2.4 (A) Vapor from Vertical Speed Brake Drain Hole

Vapor was seen trailing from the vertical speed brake aft drain hole just after liftoff (08:07:52.8 UTC) (Camera E52).
